INTRODUCTION

This report contains hydrogeologic information of interest to landowners, developers, and land-use planners concerned with the Potter Creek area of Anchor-It shows the kinds and quality of hydrogeologic data that can be obtained from a relatively sparsely developed area to guide further development. Among the hydrogeologic features that affect development in the Potter Creek area are conditions created by erosion and poor drainage, the availability of water supplies, and the suitability of land for onsite liquid-waste disposal.

The Potter Creek study area encompasses approximately 16 mi2; about onethird of this area is in Chugach State Park. To obtain information on which to base long-range planning and management of the Potter Creek area, the U.S. Geological Survey and the Municipality of Anchorage jointly funded a hydrogeologic study of the area. This project is a southward extension of earlier work in the Hillside by the U.S. Geological Survey (Dearborn and Barnwell, 1975). The significance of hydrology for land-use planning, especially as it applies to the Hillside, is discussed in greater detail in the 1975 report.

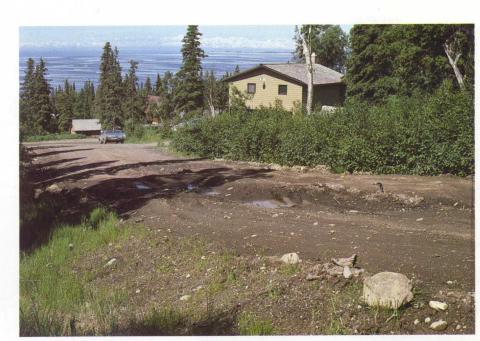
Figure 3a. -- Road damaged by seepage of shallow ground water (172nd Avenue near Goldenview Drive, June 1979.

Except for the Old and New Seward Highways, all roads in the Potter Creek area are unpaved. In winter, ice builds up where ground water seeps onto road surfaces. In spring, runoff from melting snow and ice causes locally uneven, muddy surfaces where drainage is poor, or it may erode the roadway or, in more extreme cases, cause washouts. In places, roads are not passable for periods of time each spring. Some sites where drainage, icing, and erosion have damaged road surfaces or created other problems are shown in figures 3a-d. In addition to the inconvenience and hazards created by these road conditions, erosion of road surfaces and embankments adds to the suspended-sediment loads of nearby streams, which affects water quality. Although road washouts and winter icings are highly visible and sometimes spectacular, they are not the only problems that can arise in poorly drained soils. Ground-water seepage and frost heave can cause structural damage to houses as well as roads. In addition, shallow ground water can prevent proper functioning of septic systems. Special attention to potential drainage problems during design and construction of roads and houses can reduce or

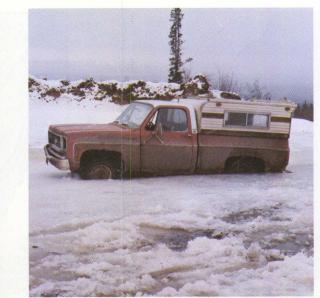
Figure 3b. -- Hazardous road conditions created by malfunctioning road drainage systems and freezing of subsequent ground-water seepage (Goldenview Drive, December 1980).

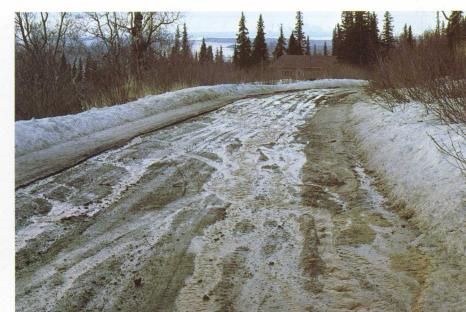
Figure 3c. -- Erosion of road by melt water during the spring (Spain Drive near Potter Creek, April 1980).
